L. William Pearce
Site Vice President724-682-5234
Fax: 724-643-8069December 29, 2004
L-04-158U. S. Nuclear Regulatory Commission
Attention: Document Control Desk
Washington, DC 20555-0001**Subject: Beaver Valley Power Station, Unit No. 1
BV-1 Docket No. 50-334, License No. DPR-66
Reactor Head Inspection 60-Day Report for 1R16**

**Evaluation Report for
1R16
Beaver Valley Unit 1
Reactor Vessel Head Penetration
Inspections
(Ref: Order EA-03-009)**

December 2004

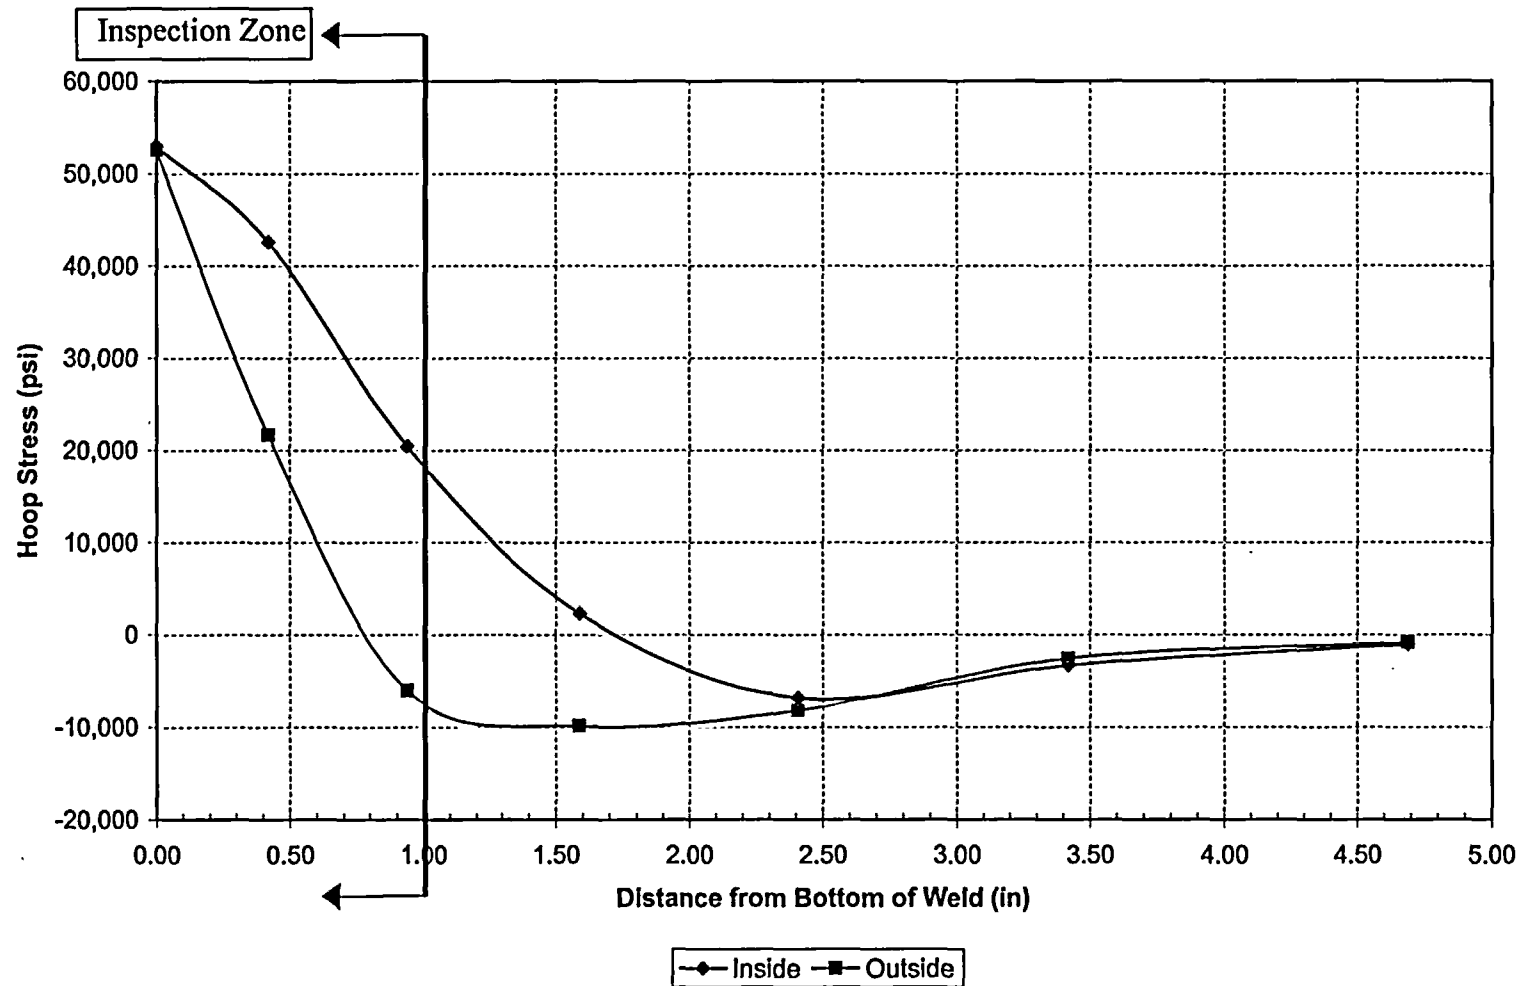
Figure 1
Hoop Stress Vs Distance from Bottom of Weld
0° CRDM Center Penetration Nozzle – Uphill and Downhill

Underhead NDE examinations were performed using a combination of ultrasonic and eddy current examination techniques, in accordance with the requirements of Paragraph IV.C.(5)(b)(iii). Multiple techniques had to be used in order to account for difficult penetration geometries and access limitations. (Note: Each RPV head penetration was inspected using ultrasonic OR eddy current testing. Examination techniques were not combined on any one penetration, therefore, the requirements of Paragraphs IV.C.(5)(b)(iii)(1) and (2) do not apply.) In all cases (ultrasonic or eddy current), the minimum examination coverage extended from 2 inches above the highest point of the root of the J-groove weld to 1 inch below the lowest point at the toe of the J-groove weld. For BVPS Unit 1, the minimum required coverage below the toe of the J-groove weld is 1 inch, as a plant-specific stress analysis has been performed (WCAP-16071), and tensile stresses beyond 1 inch below the J-groove weld are shown to be < 20 ksi in all cases, as shown in Attachment A.
